Navajo Abandoned Uranium Mine

Site Screen Report

Mine Name: AEC Sample 13756 & USGS Sample MV-8
Mine ID: 243

Navajo AUM North Central Region

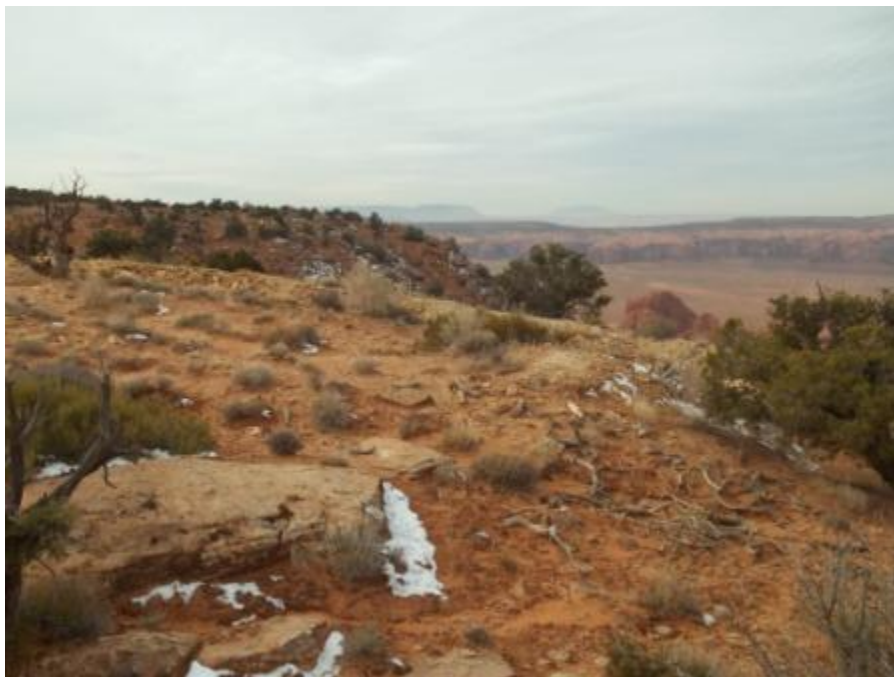
Photo 1

Mine Site #243

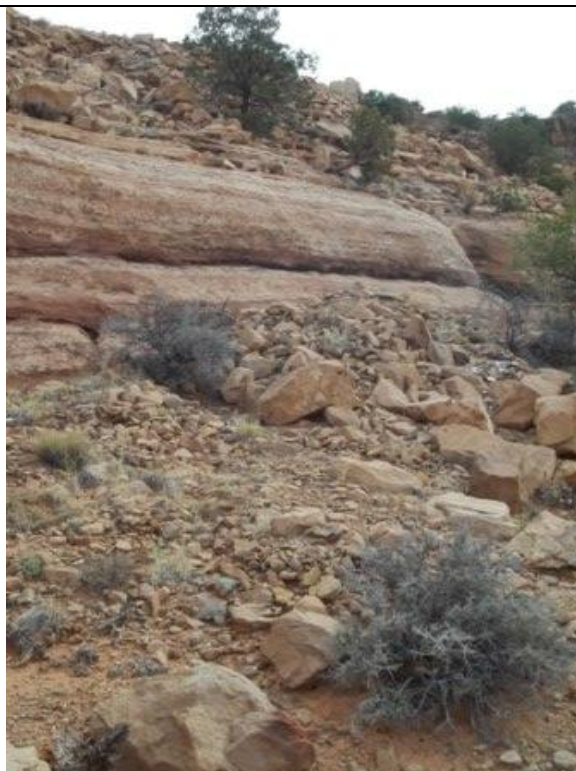
Photo 2

Mine Site #243

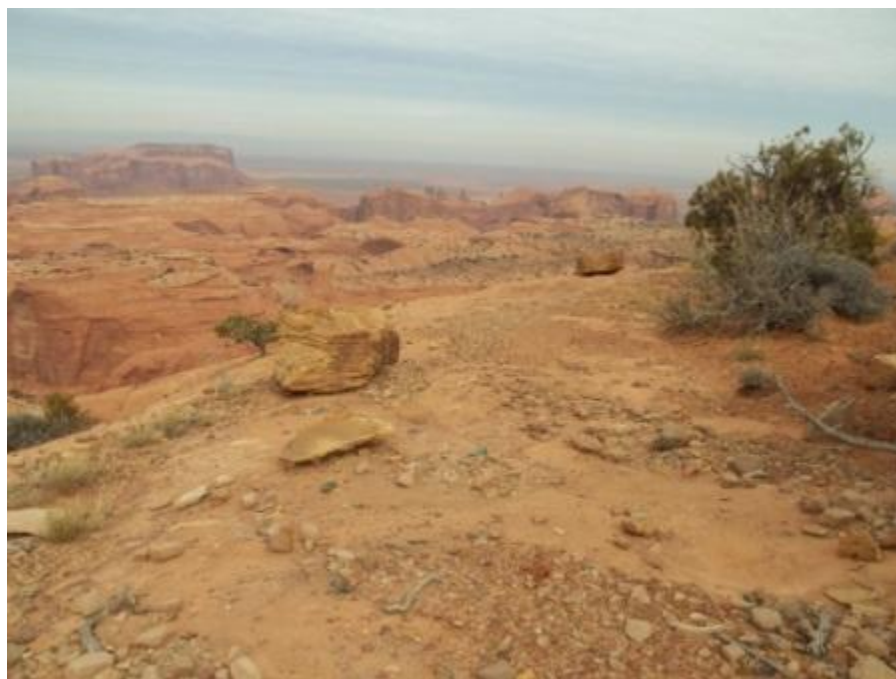
Photo 3

Mine Site #243

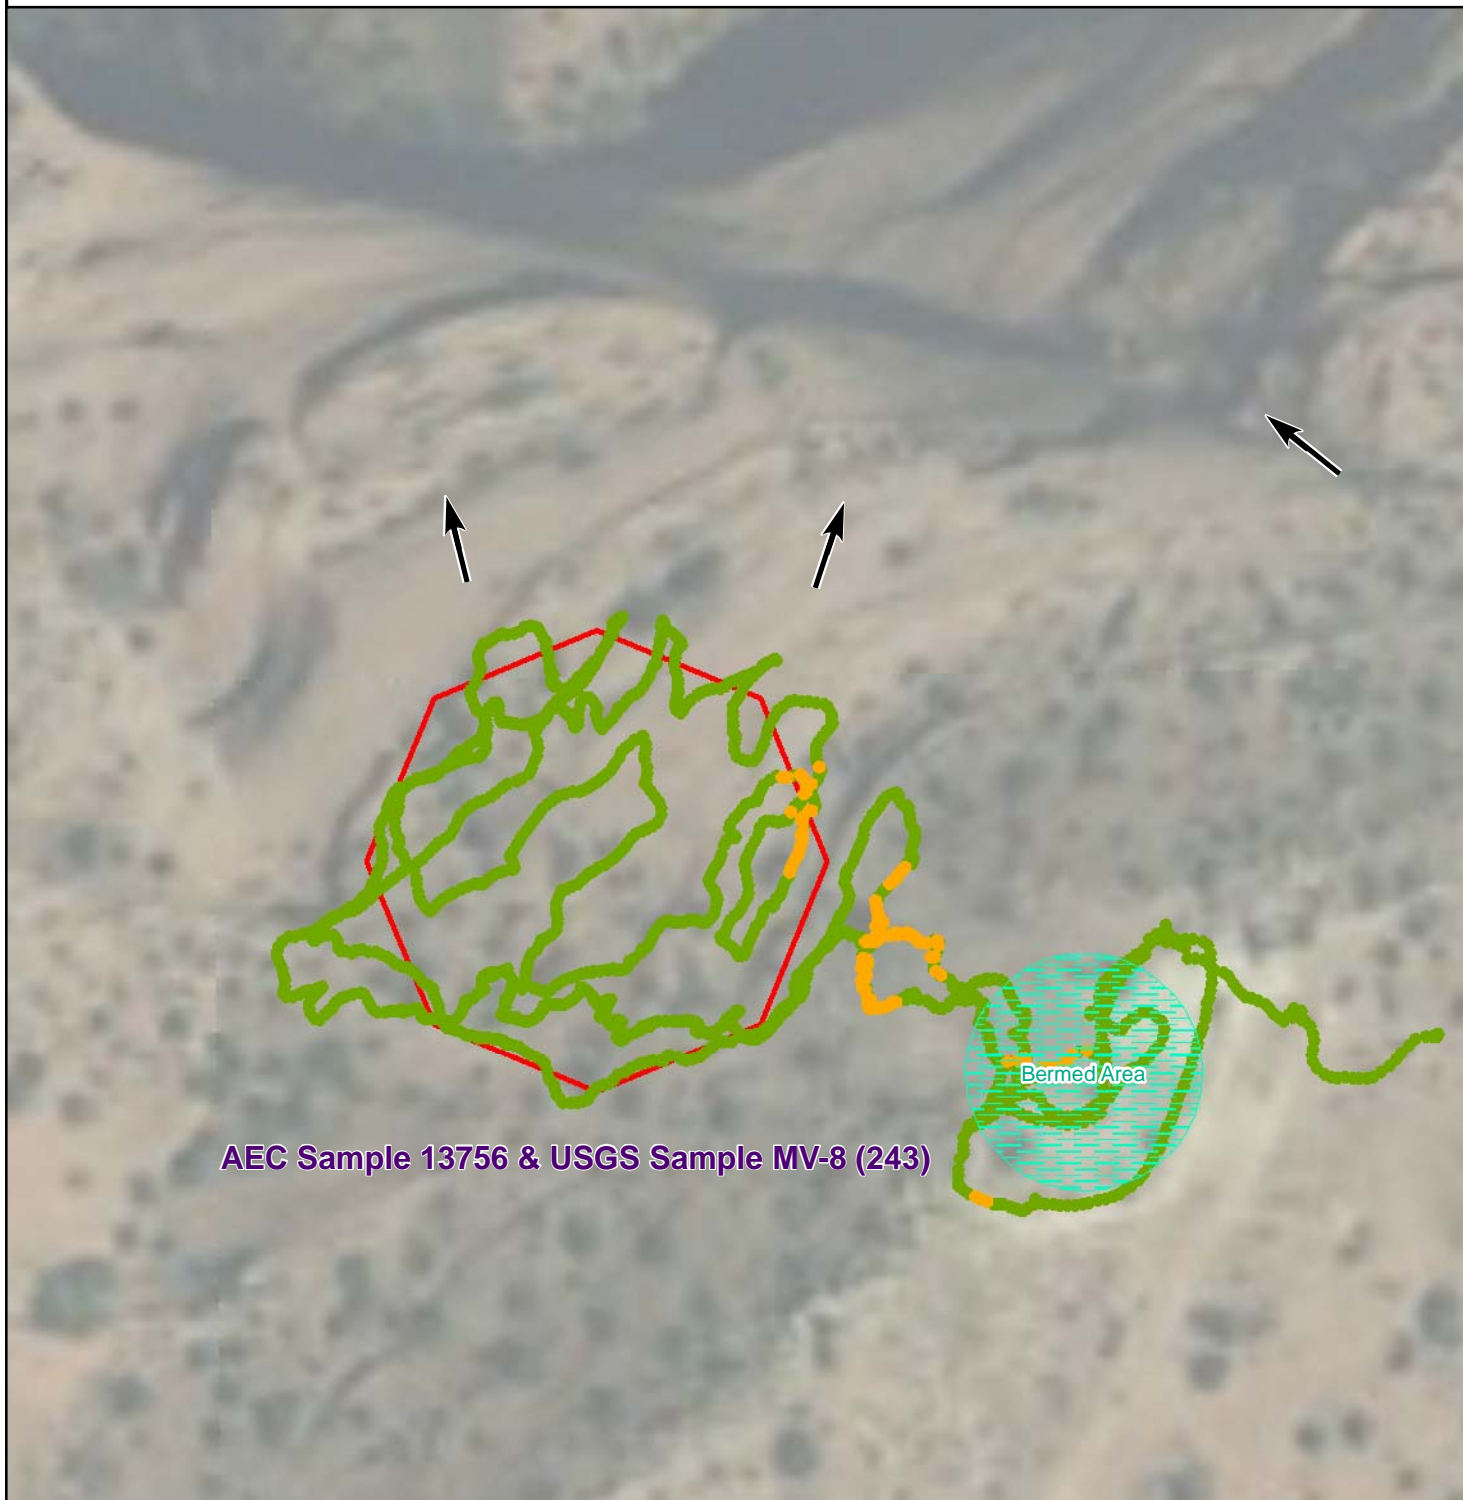
**Figure 1 - Gamma Radiation Measurements, Above Two Times Background
AEC Sample 13756 & USGS Sample MV-8 (243)
Kayenta Chapter, Navajo Nation**

Gamma Radiation Measurements

Measured as counts per minute (cpm)

Average background 7,136 cpm

A total of 2,183 gamma radiation measurements were collected from the mine site, ranging from 5,107 cpm to 23,424 cpm. The measurements are represented in Figures 1 and 2.
